# EMERGENCY ACTION PLAN

# FORGE POND DAM & DIKE

**GRANBY, HAMPSHIRE COUNTY, MASSACHUSETTS**

National I.D. Number: MA00488/MA00489

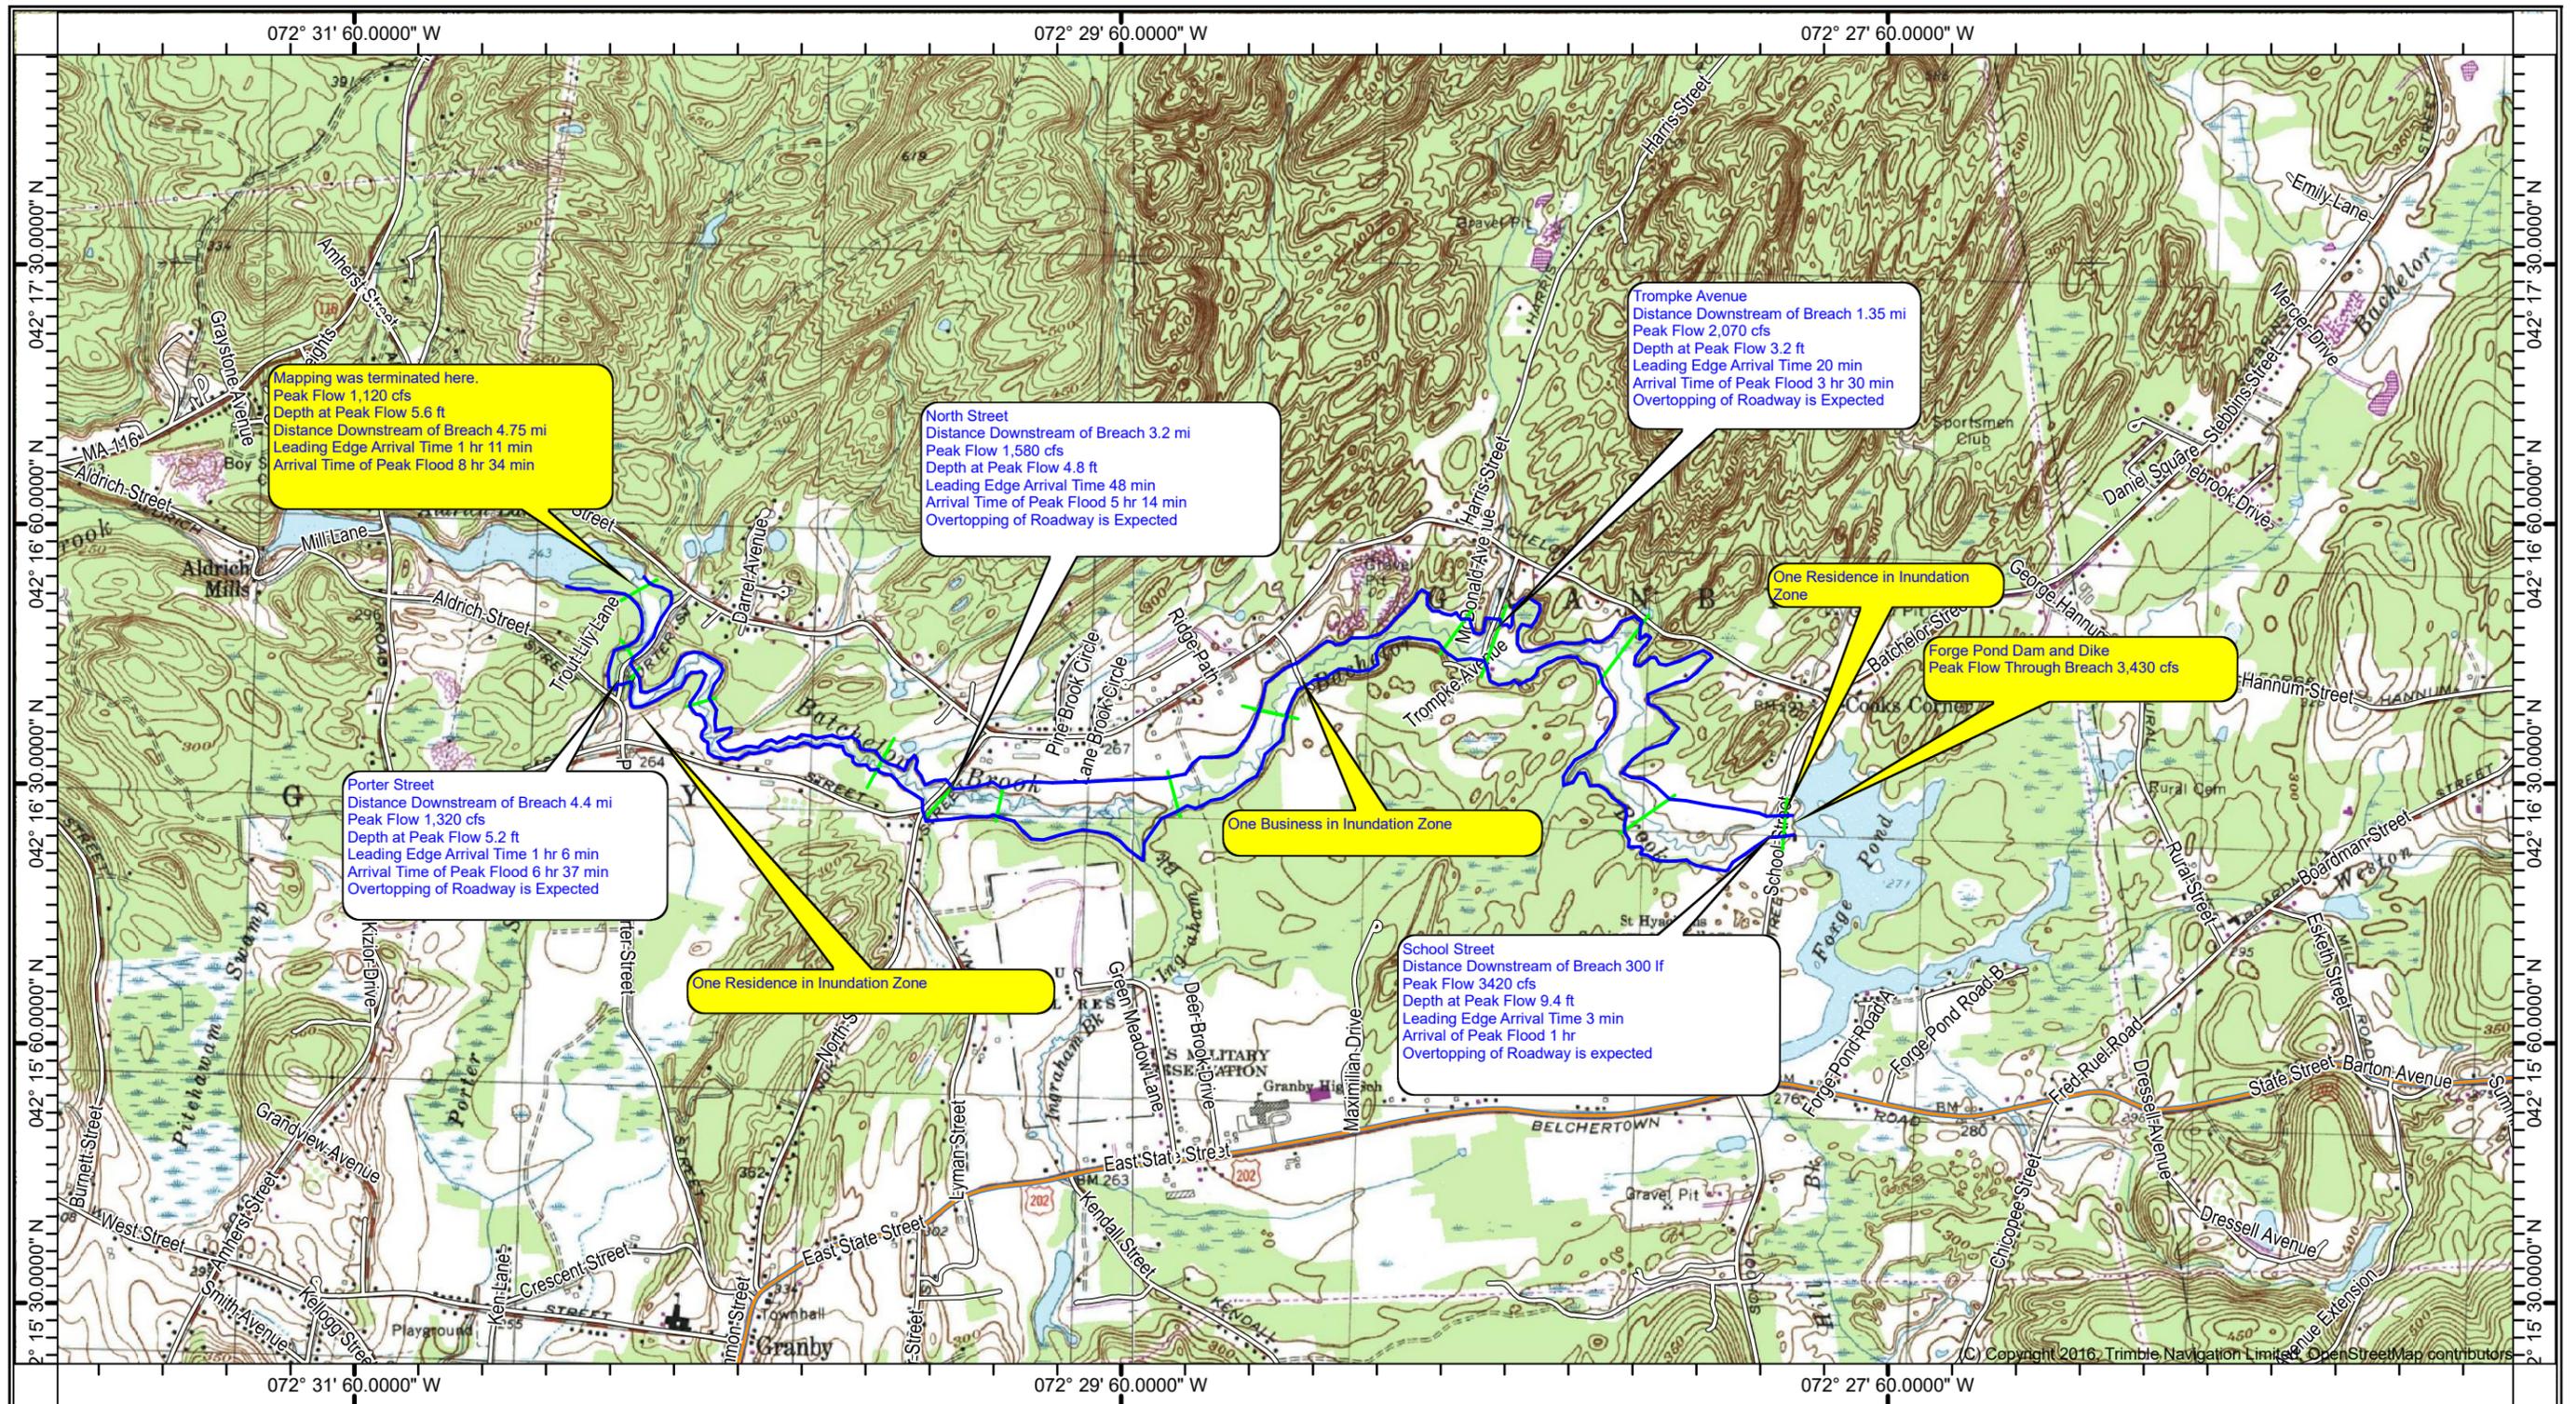
**INUNDATION MAP FOR  
 FORGE POND DAM AND DIKE  
 GRANBY, Massachusetts**

— Cross Section Location  
 — Boundary for area flooded by dam failure.

The downstream flooding from failure of Forge Pond Dam was estimated by Lenart Consulting Service, LLC using Simplified Dam Break (SMPDBK) software (see Section 4.0). Based on the analysis, the downstream flooding is expected to impact portions of the Town of Granby along Batchelor Brook. The estimated peak flow through the dam breach is 3,430 cfs. See Section 4.0 for an inundation map as well as more information on roadways and buildings in the downstream inundation zone.

- Type of Dam: Concrete and masonry spillway and vertical stone masonry wall on the downstream side
- Dam Breach Elevation (ft, NAVD88): 273.5 (at top of dam)
- Storage Volume at Failure (acre-ft): 380
- Surface Area of Reservoir (acres): 72
- Final Breach Width (ft): 30
- Time to Failure (min): 60
- Final Breach Elevation (ft, NAVD88): 260
- Antecedent Flow Through Dam: None
- Antecedent Downstream Flooding: None
- Failure Mode-Overtopping

Based on the analysis, the downstream flooding is expected to impact portions of the Town of Granby along Batchelor Brook including School Street, Trompke Avenue, North Street, Porter Streetone private residence and one business.

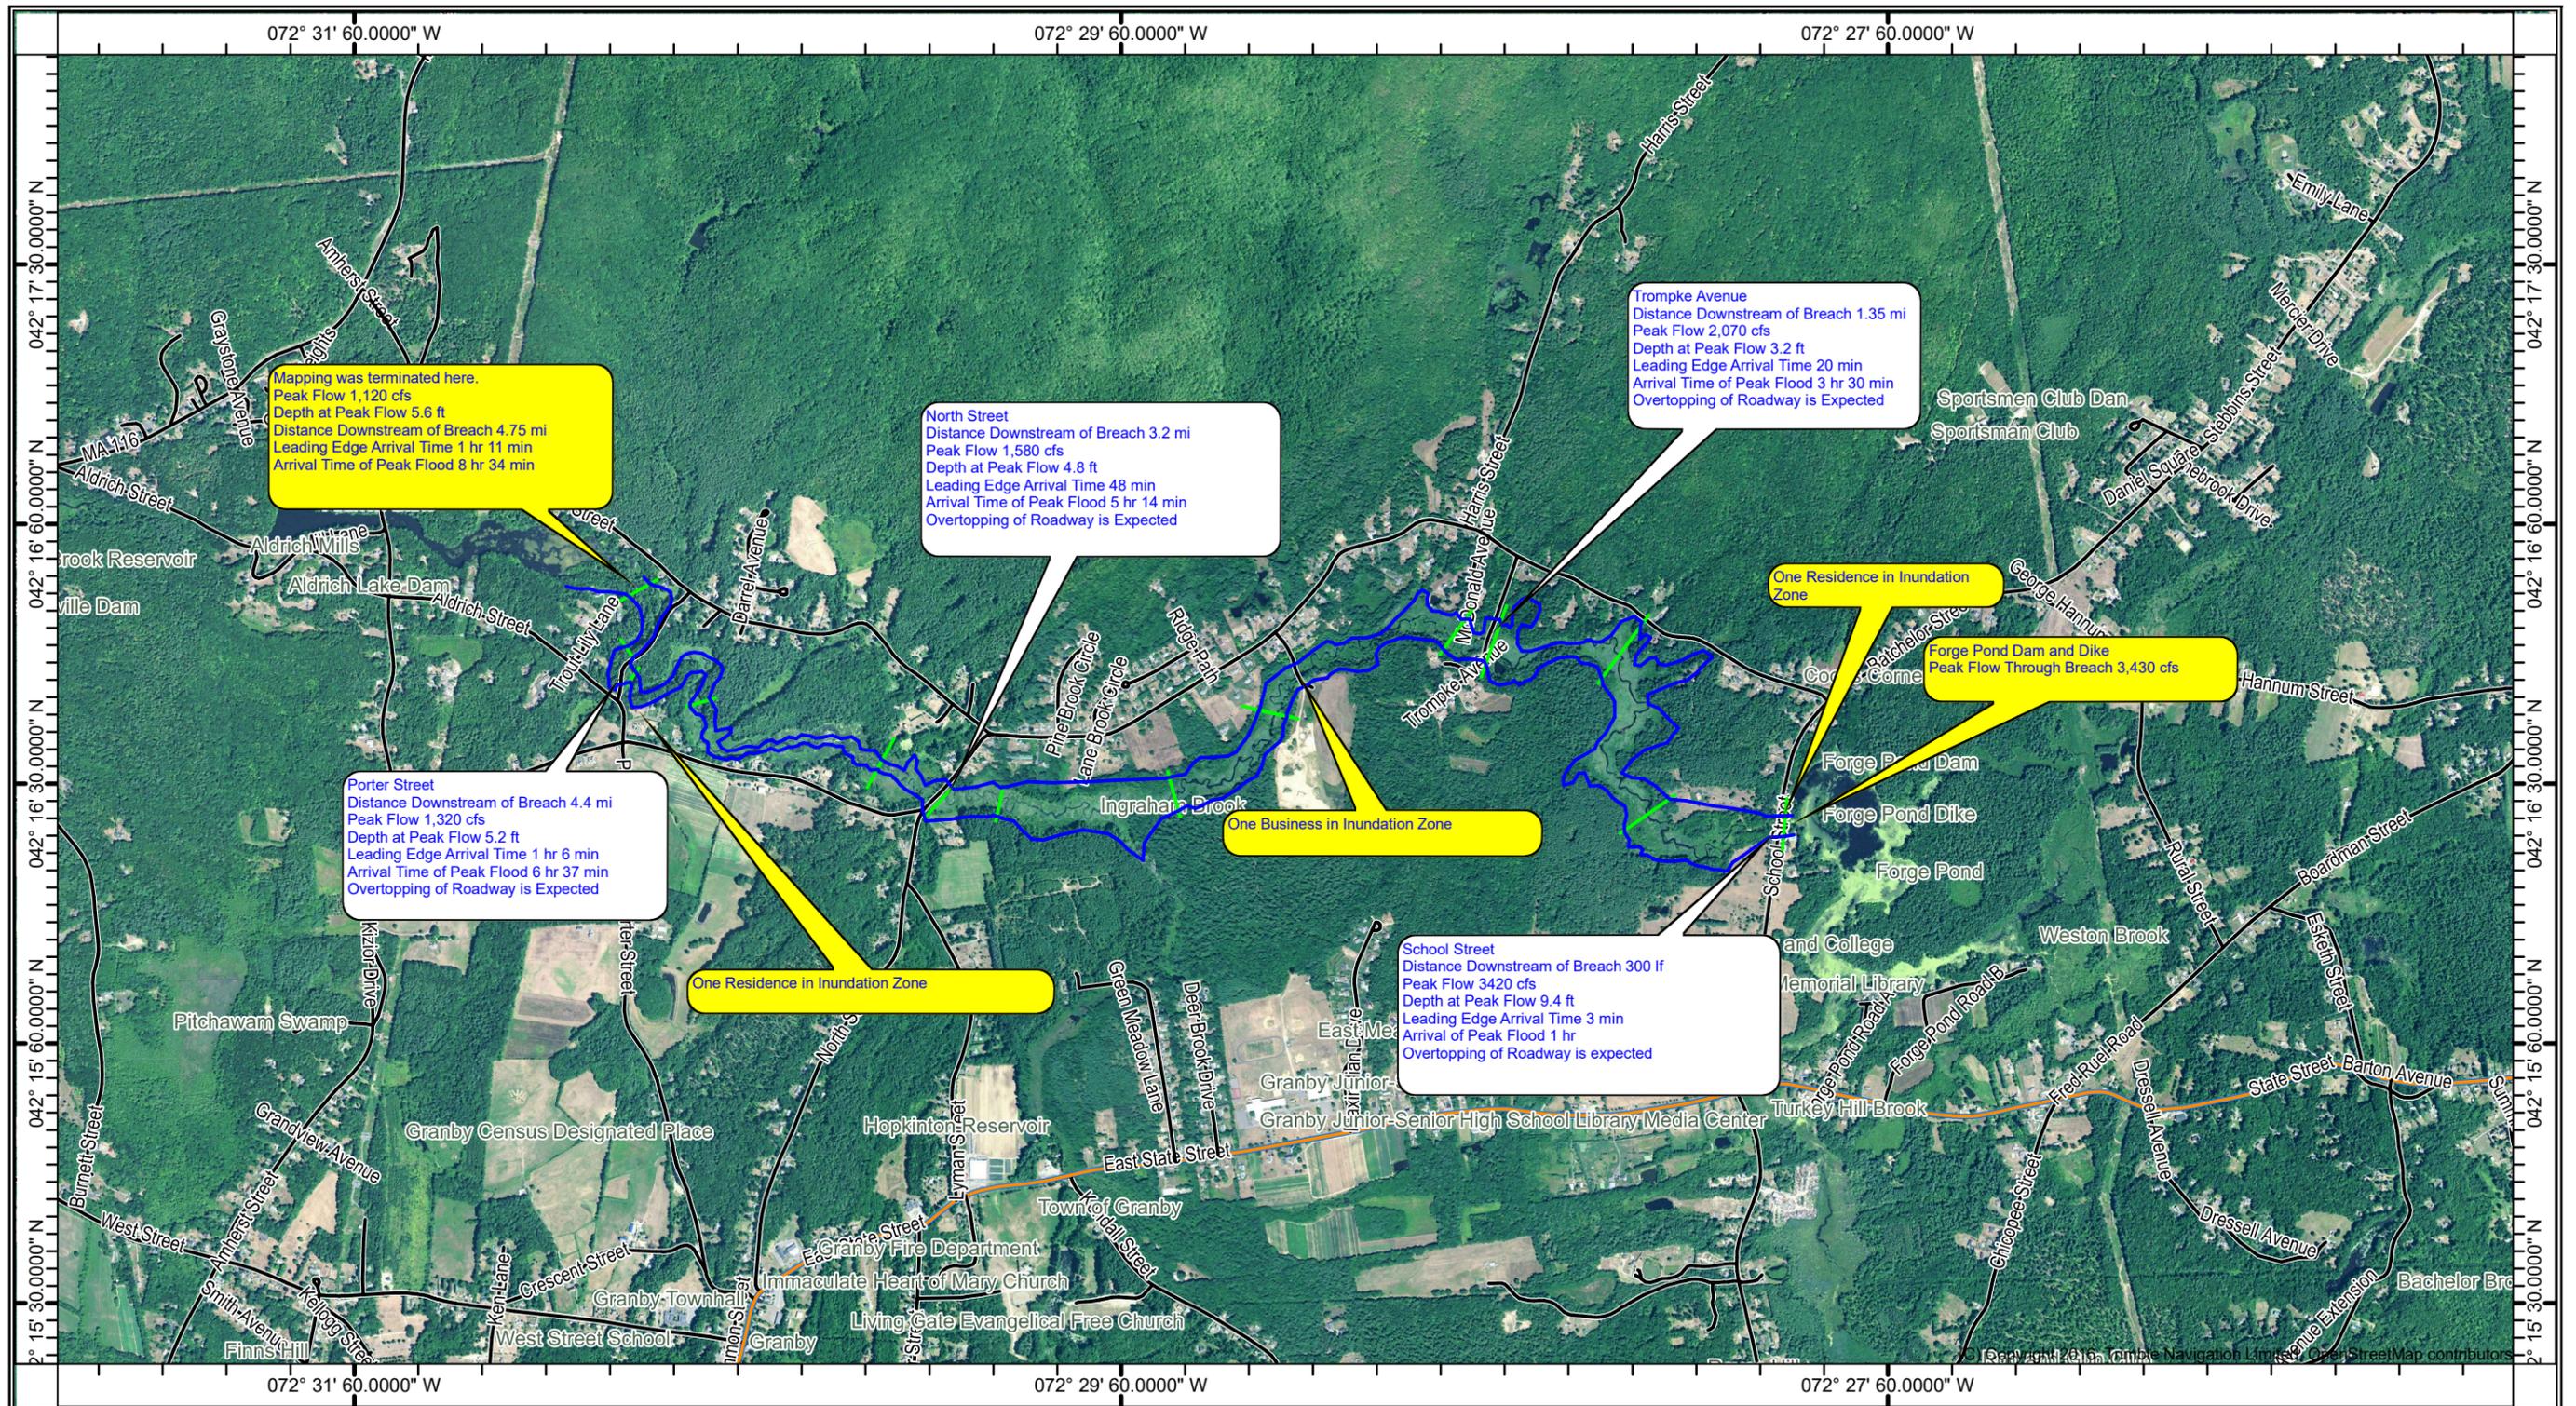
Mapping was terminated here.  
 Peak Flow 1,120 cfs  
 Depth at Peak Flow 5.6 ft  
 Distance Downstream of Breach 4.75 mi  
 Leading Edge Arrival Time 1 hr 11 min  
 Arrival Time of Peak Flood 8 hr 34 min

North Street  
 Distance Downstream of Breach 3.2 mi  
 Peak Flow 1,580 cfs  
 Depth at Peak Flow 4.8 ft  
 Leading Edge Arrival Time 48 min  
 Arrival Time of Peak Flood 5 hr 14 min  
 Overtopping of Roadway is Expected

— Cross Section Location  
 — Boundary for area flooded by dam failure.
